# SYSTEMS REPAIR FUNDING INCREASES IRRIGATION CAPACITY

## **Systems Repair funding increases irrigation capacity and helps improve water quality entering local waterways.**

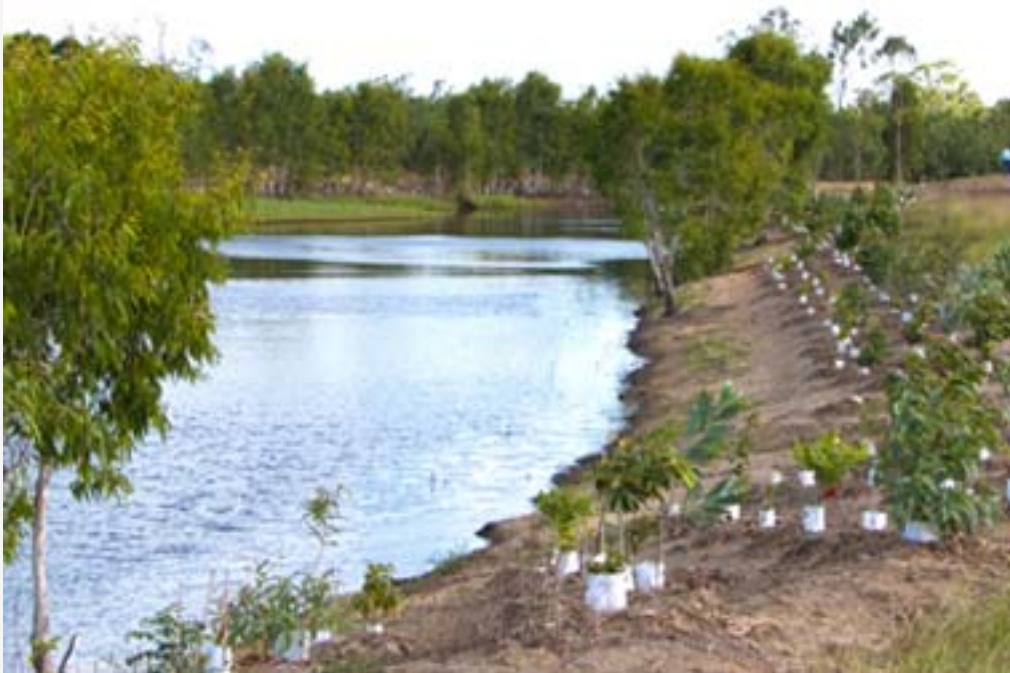
Rehabilitation works at Shane Cowley's property, Bakers Creek. Shane has been able to increase the on-farm water supply available for cane farm irrigation by installing a sediment detention basin and second flush chamber directly upstream from his wetland.

With assistance from the Australian Government Reef Programme (Systems Repair), Shane was able to build a 1 ML first flush detention basin that catches most of the sediment in the runoff water entering his farm.

A second flush chamber was also created, consisting of a shallow macrophyte (sedges) zone for filtering nutrients and fine sediment from the water. The second flush chamber features a 3 ML waterhole at its end to supply irrigation water.

The water flows over a rock weir at the end of the waterhole into Shane's wetland, ensuring cleaner re-oxygenated water entering the wetland.

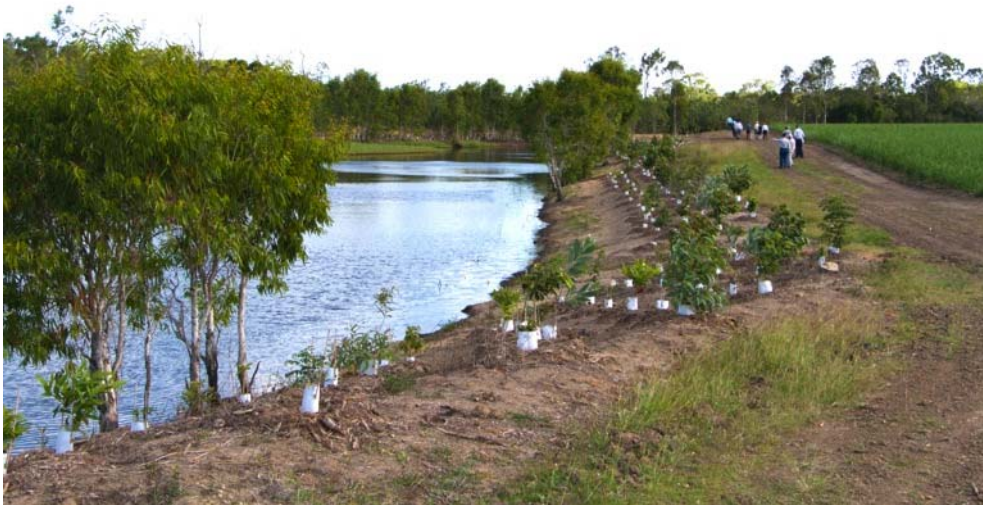
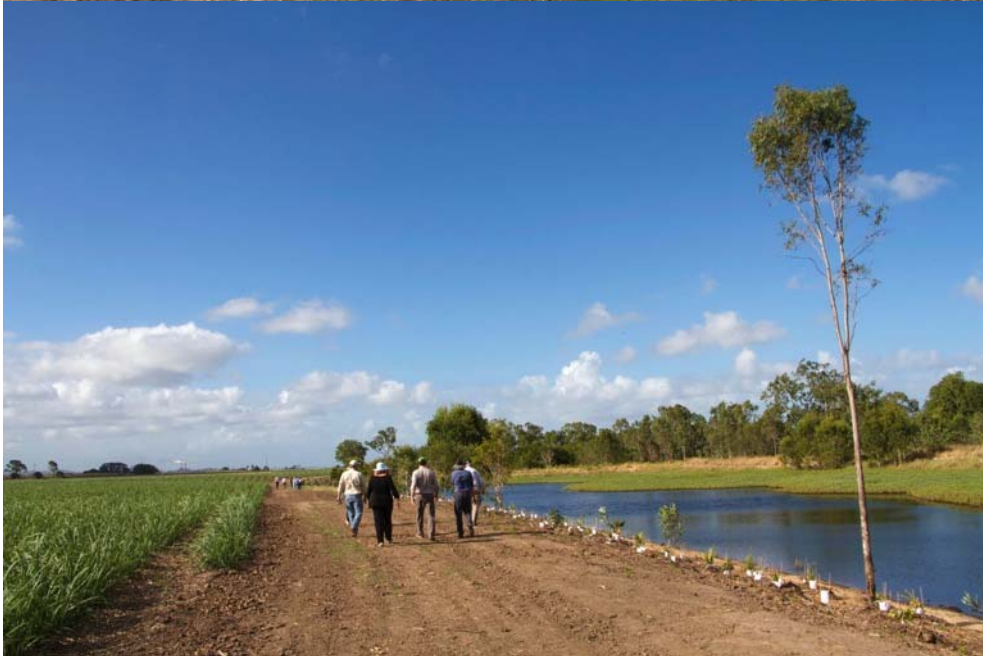
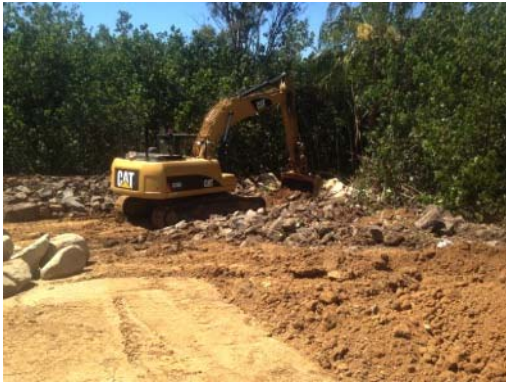
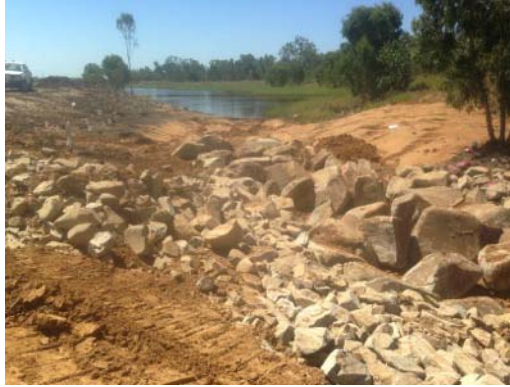
**IMG 1 - 4: Revegetation, fishway construction and wetland restoration October 2014. #**

A rock ramp fishway was incorporated at the exit of the wetland, enabling both scour protection and fish connectivity with downstream habitats. Shane is also a keen fisherman and hopes the fishway will help attract barramundi into the wetland.

Reef Catchments worked together with Shane on this project to provide help with the system design and funding for up to 50 per cent of the costs. The wetland has also been revegetated with native plants to restore habitat and connectivity.

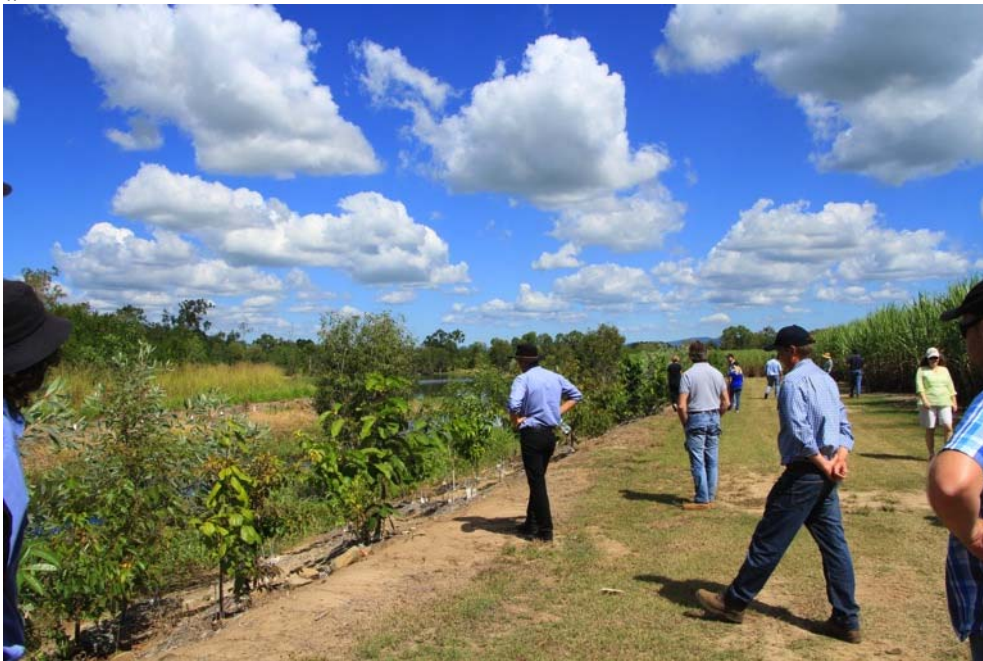
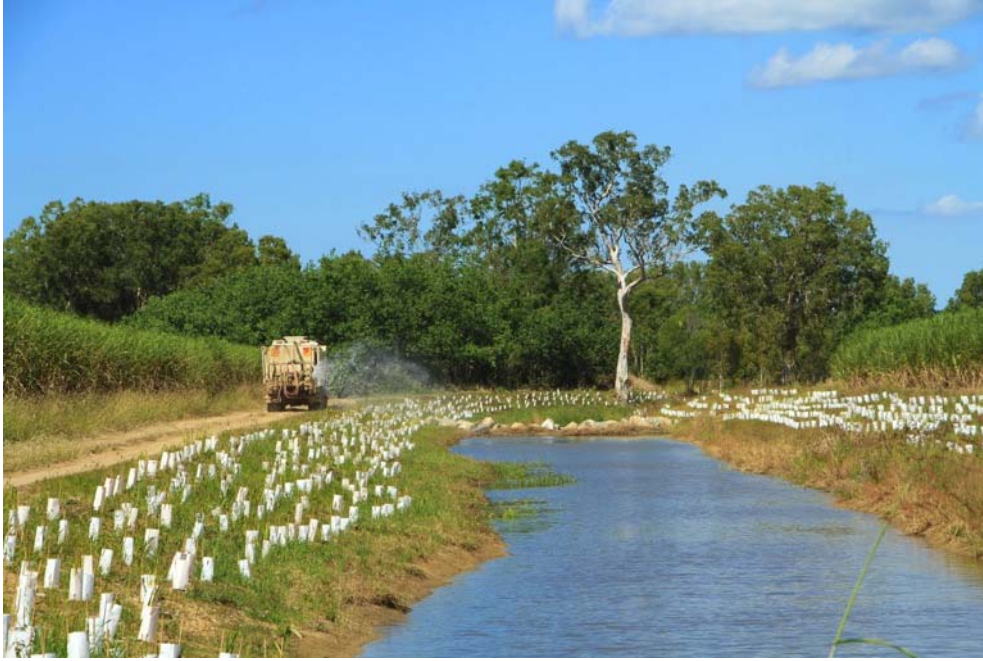
IMG 5 & 6: Revegetation and wetland restoration May 2015. #

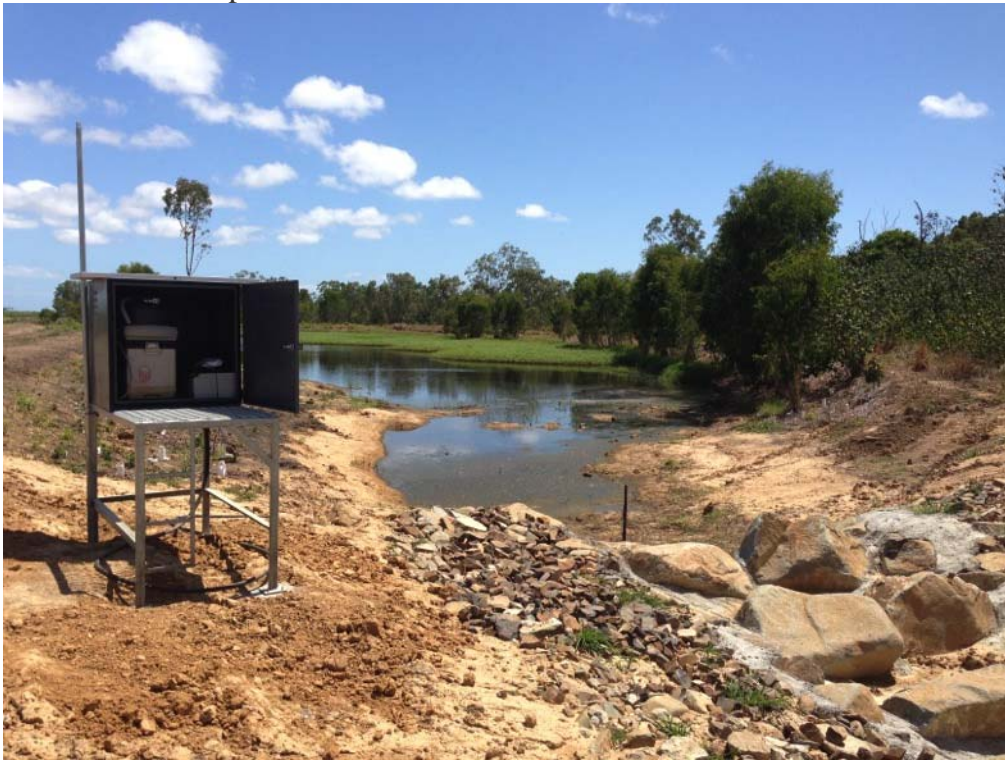
**IMG 7:** Autosampler.

The project has been successful, and is set to deliver both environmental and production benefits. An auto-sampler has been installed at the entry and exit to measure change in nutrient, sediment and pesticide loads. Early results indicate that the system is already delivering good outcomes.

"The auto-sampler will enable us to monitor the improvement that this project has had on improving water quality. It is early days and the wetland will only improve in its ability to clean the water as the macrophyte zone increases in density and the biofilms develop" said Chris Dench, Reef Catchments healthy waterways project officer.
